NBSIR 73-222 (R)

Investigation of the Skyline Plaza Collapse in Fairfax County, Virginia

E. V. Leyendecker and S. G. Fattal

Final Report

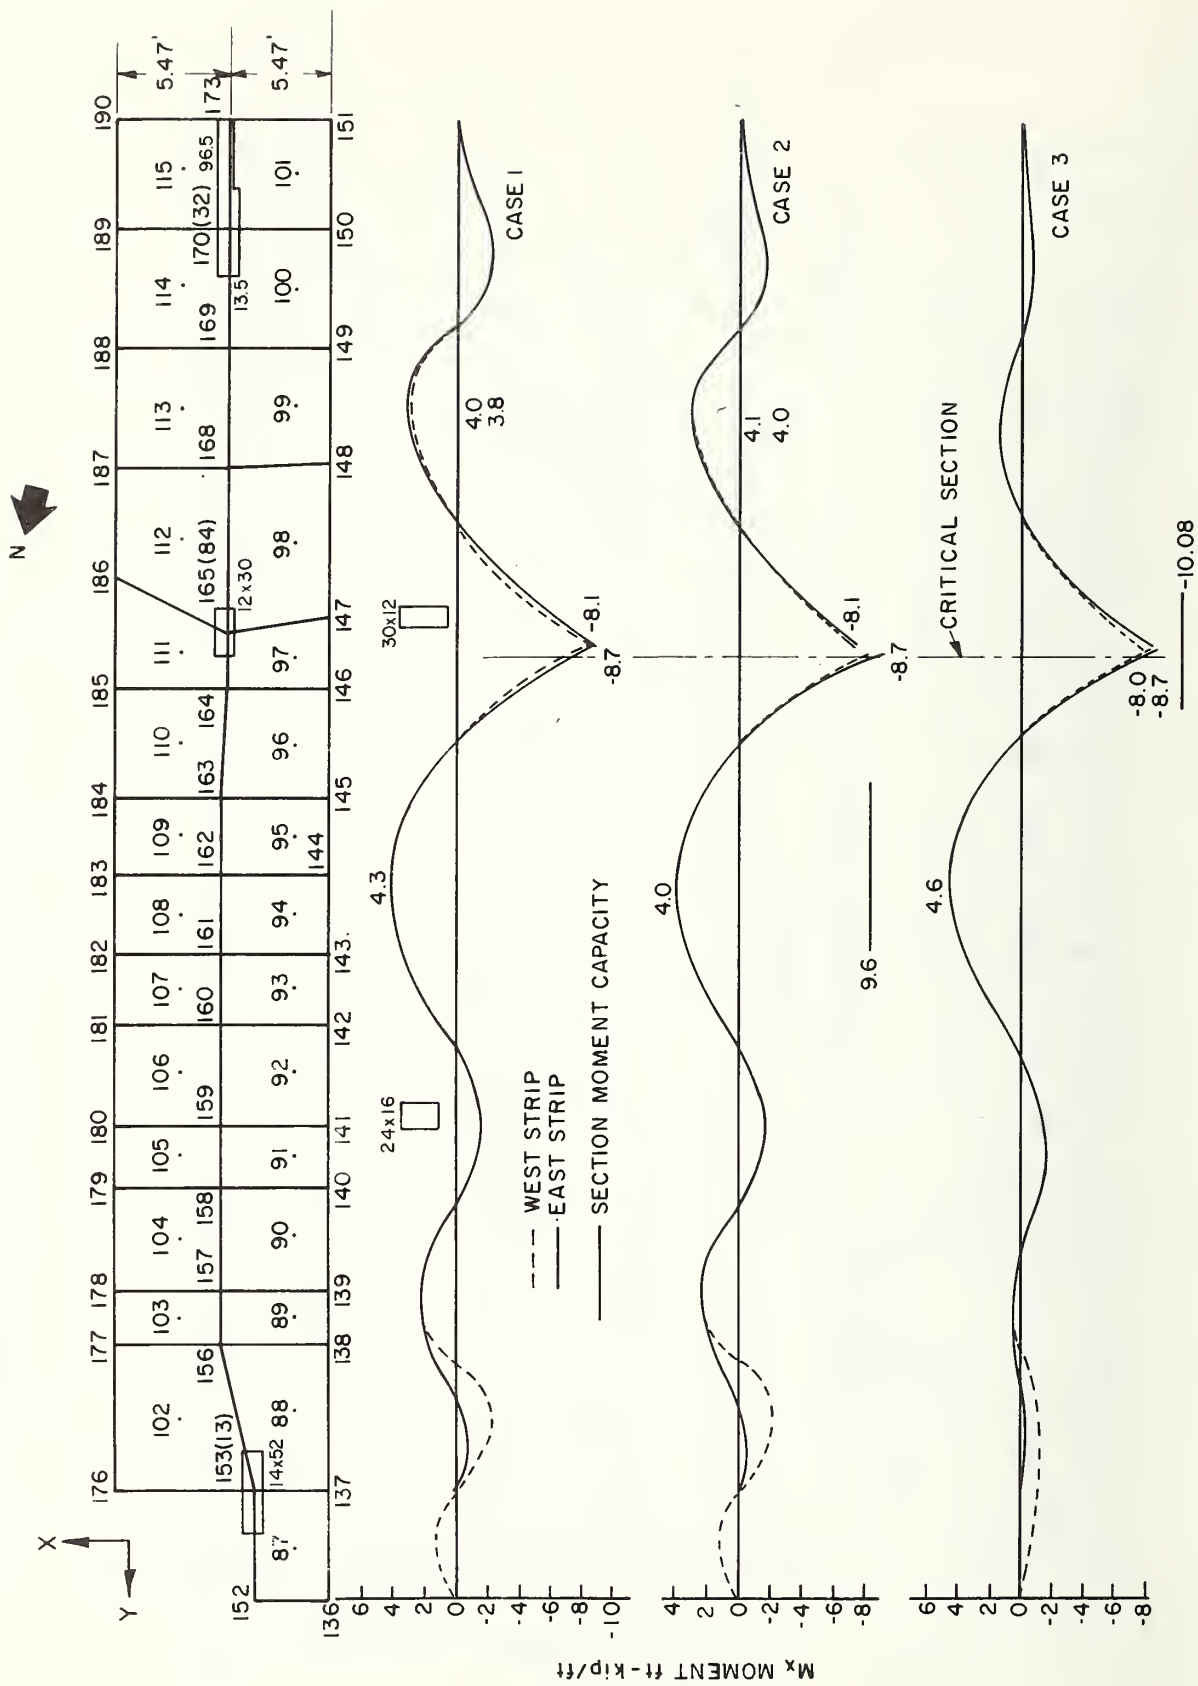
Figure 4.9 MOMENTS IN COLUMN STRIP 13-84-32

The next most severe condition occurred in the column strip shown in figure 4.9. Maximum negative moments in elements adjacent to column 84 (node 165) were in the order of 7 to 8 ft-kip/ft at the critical section. This compares with a 10 ft-kip/ft ultimate moment capacity in the slab. The difference is not large enough to preclude yielding or even some yield line propagation from column 84 in the east-west direction; however, if such yielding were to occur the situation would be very similar to the

localized condition around column 31. Again, it is concluded that this was not a significant contributory factor to the collapse of the 23rd floor.
